## Losmandy Titan Reassembly

Ed Wiley and Daniel Maloney, Stellar Skies Observatories

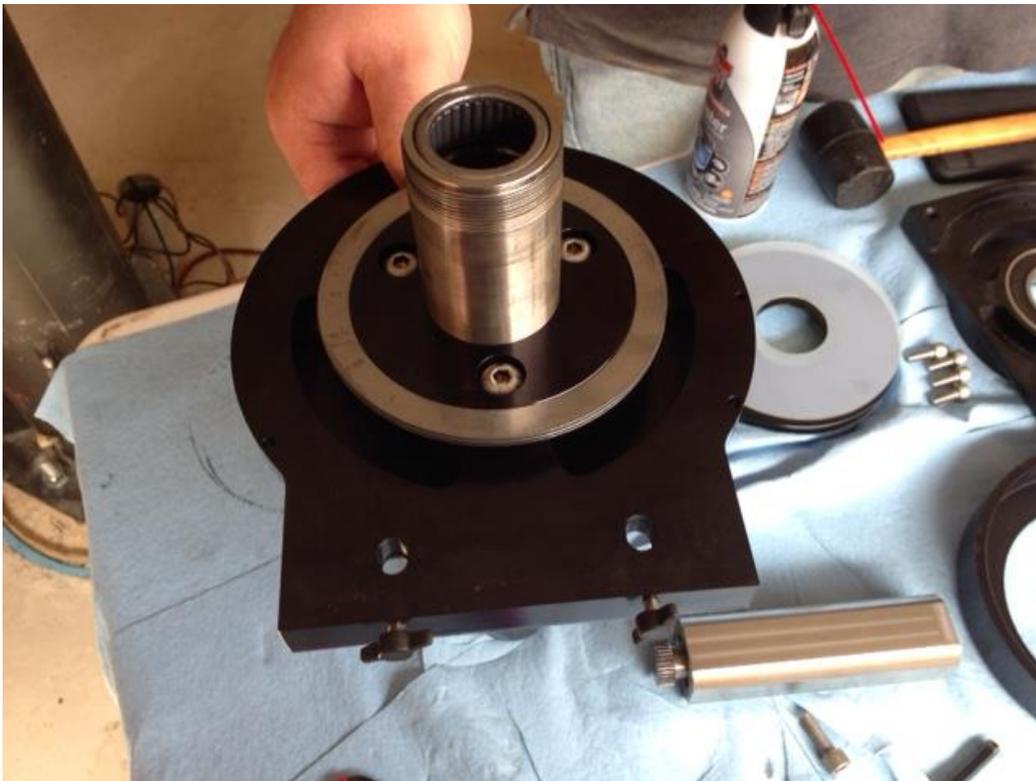
Photo 1. Race bearing placed on the Dec housing. Note that bearing has been degreased as much as possible and lubricated.

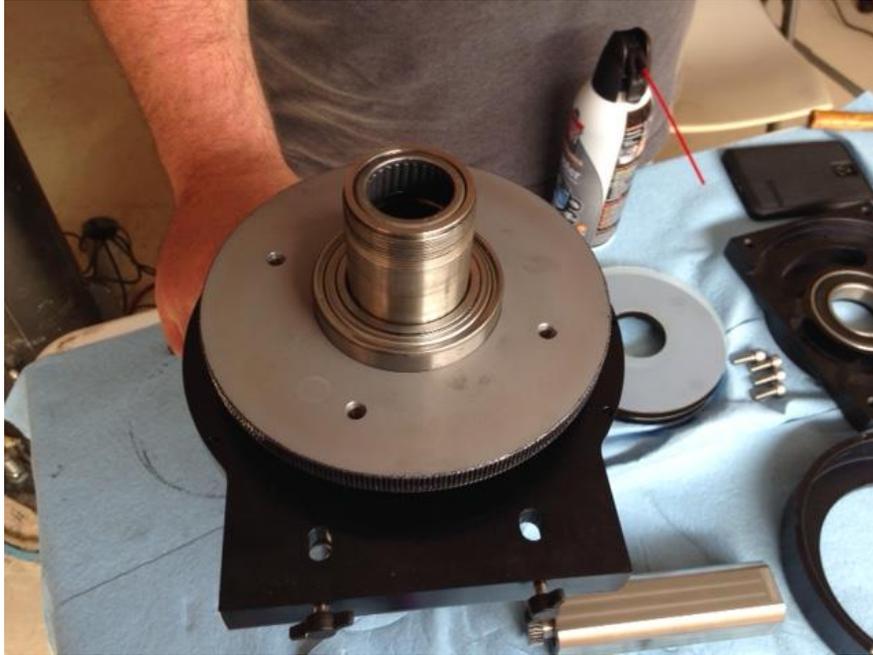
Photo 2. Dec gear placed on top of race bearing (again after clearing and lubricating).

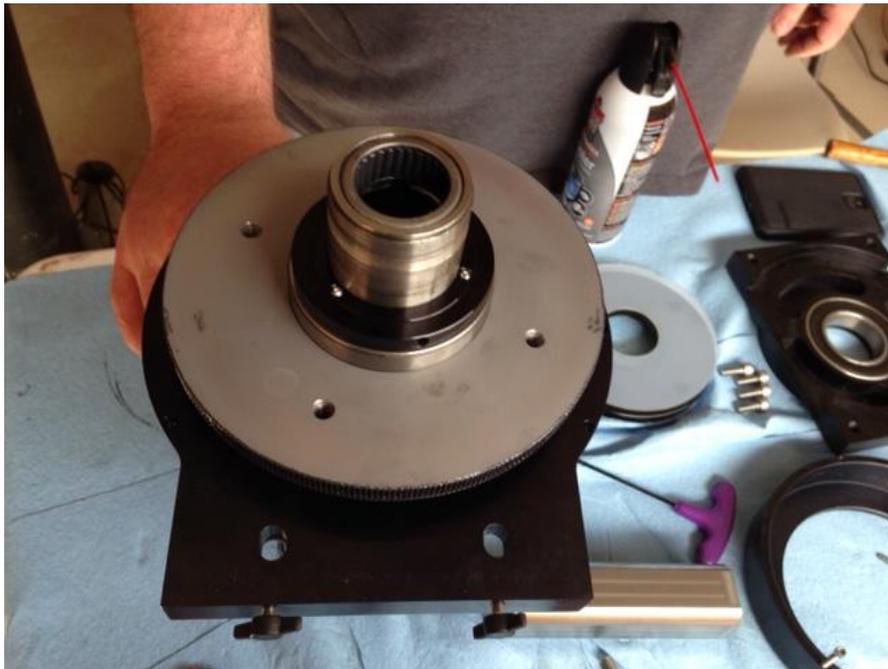
Photo 3 Gear "keeper" installed. It's important to insure that the Dec gear is properly seated with gentle pressure during tightening of the "keeper."

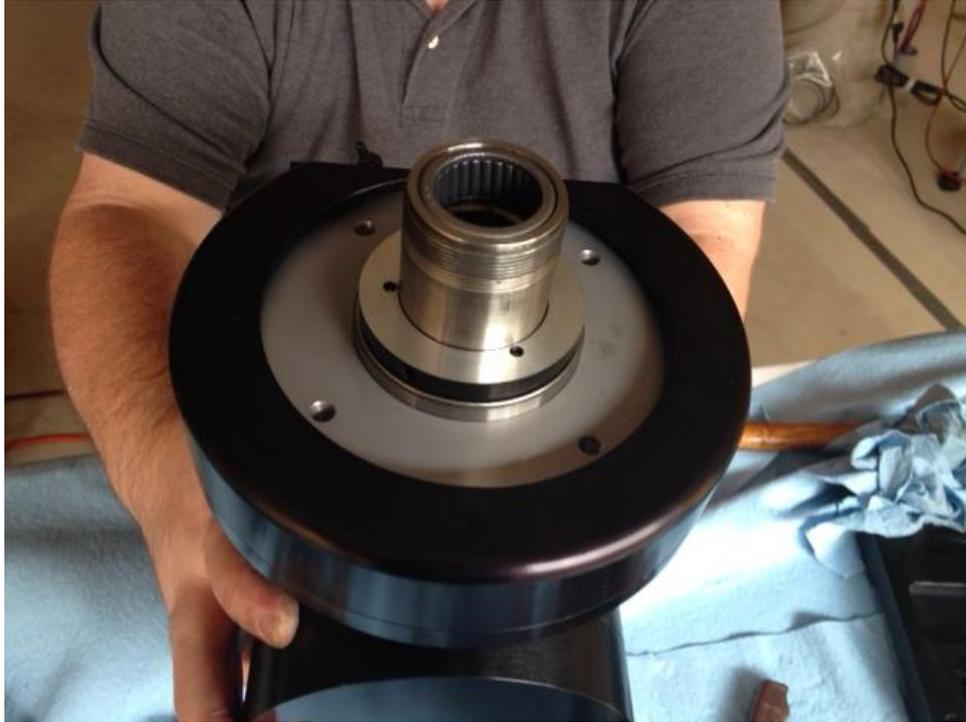
Photo 4. Gear housing fitted. Make sure that during installation you do not bump the gears.

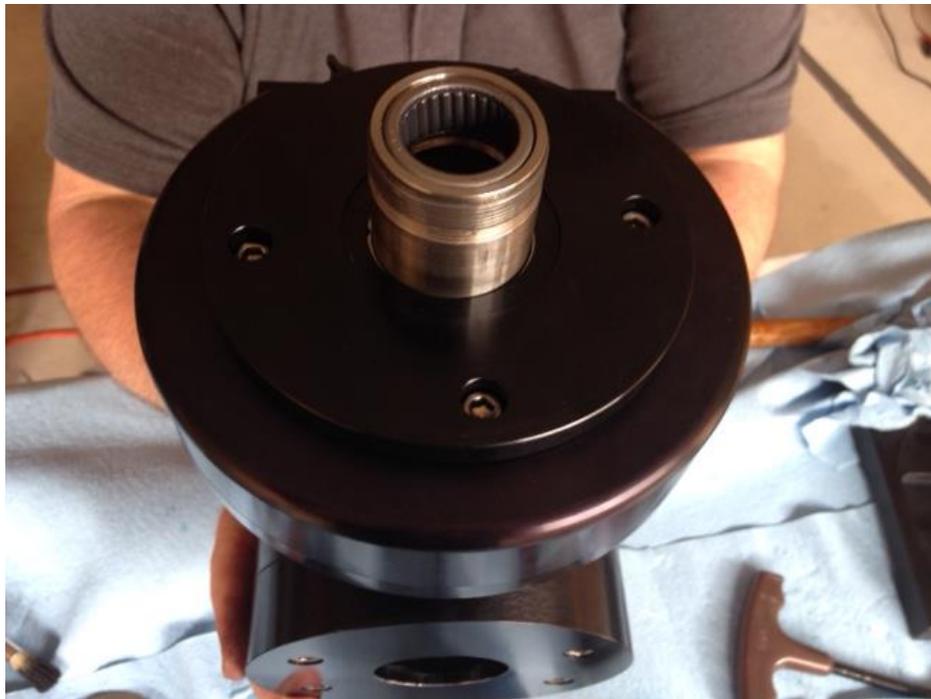
Photo 5. The bottom clutch plate is then installed.

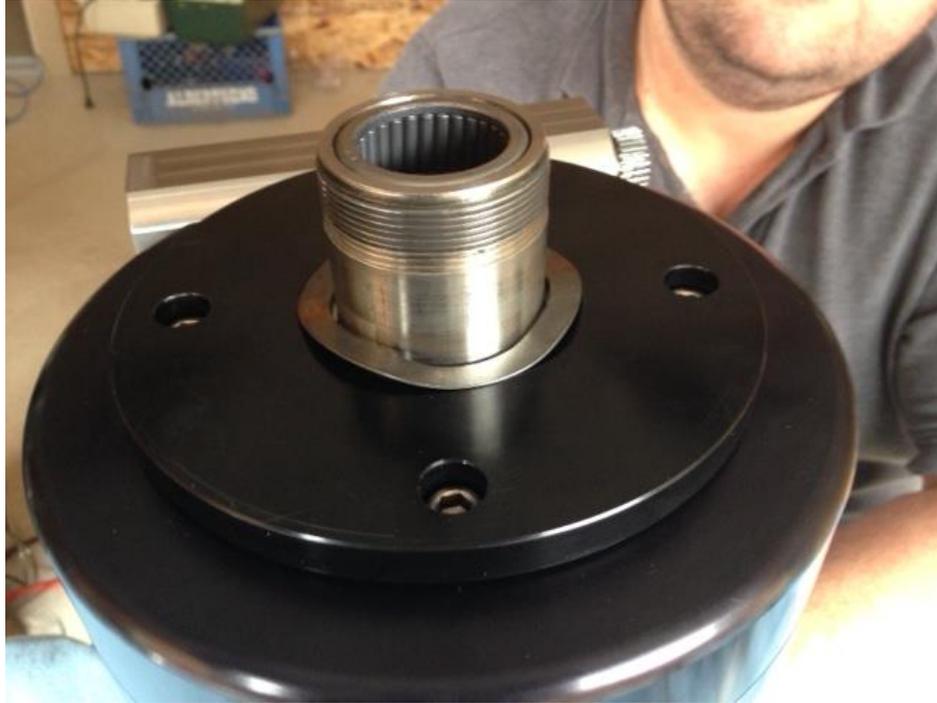
Photo 6. This is the first part of the installation that differs from Titan Tips. Compare to photos 8 and 9 below. The wavy washer is installed in the machined recess of the lower clutch plate BEFORE the installation of the clutch pad (see Photo 7).

The RA assembly is relatively simple. In particular, the wavy washer goes into the machined recess of the of the lower clutch face behind the clutch.

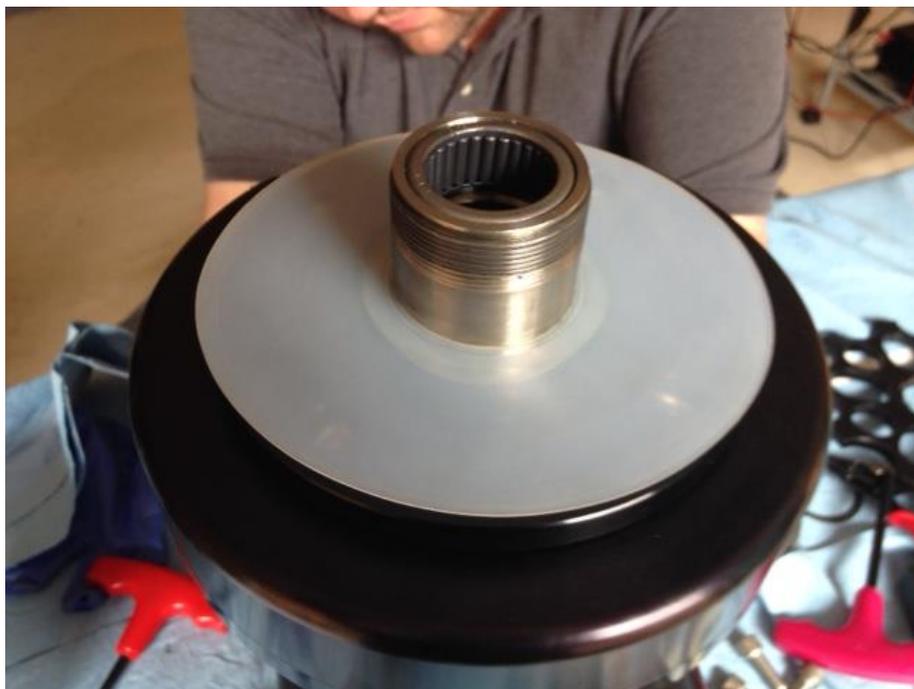
Photo 7. The clutch pad is installed directly over the wavy washer.

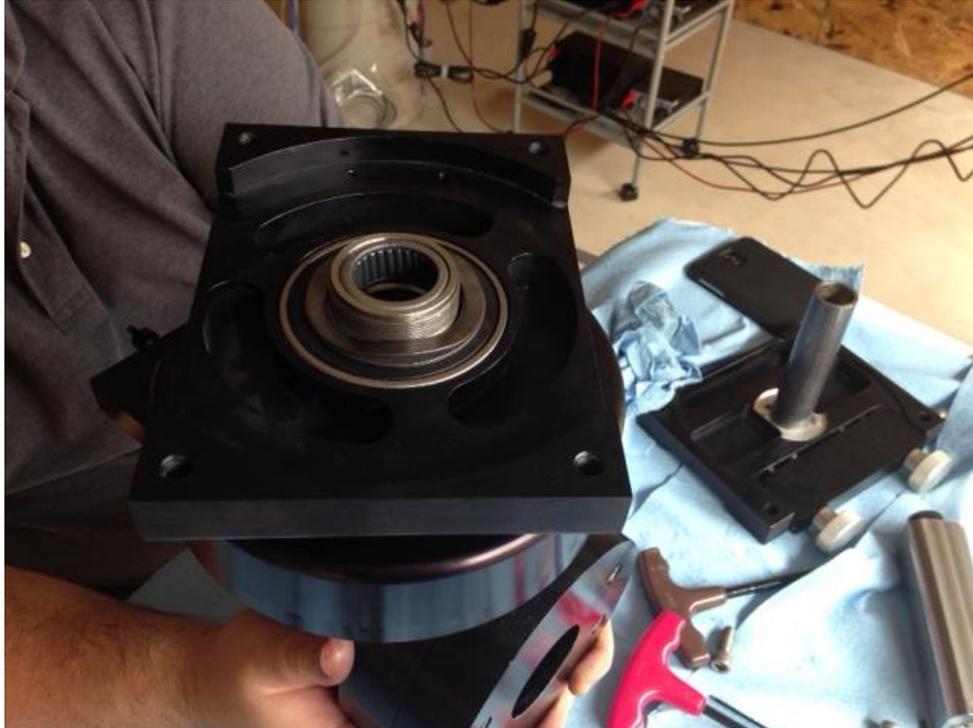
Figure 8. The plate that holds the Pressure Wheel is slipped onto the shaft. Note there that there are two washers, a normal one under the wavy washer. This is NOT correct for this mount. There should only be the normal washer, the wavy washer was installer earlier over the lower clutch plate.

1. It is entirely possible that the "Titan Tips" placement of the wavy washer below the pressure wheel was correct for that particular Titan. When we tried that configuration the pressure wheel suffered binding.
2. Although the "Titan Tips" suggests that the hex screws that hold the worm housing should be loose, we found that the worm housing wiggled when hex screws were loose. Snugging them up did not seem to affect worm performance.

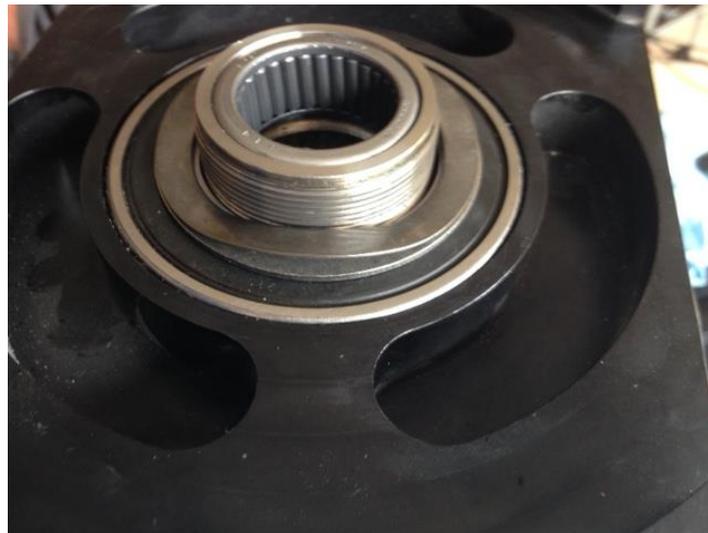
Photo 9. Detail of Photo 8. Again, ONLY the flat washer is installed, NOT the wavy washer and not two wavy washers. More explanation: If you try to install as in this photo, the pressure wheel does not work properly, it binds because there is not enough clearance once the snap ring is installed.

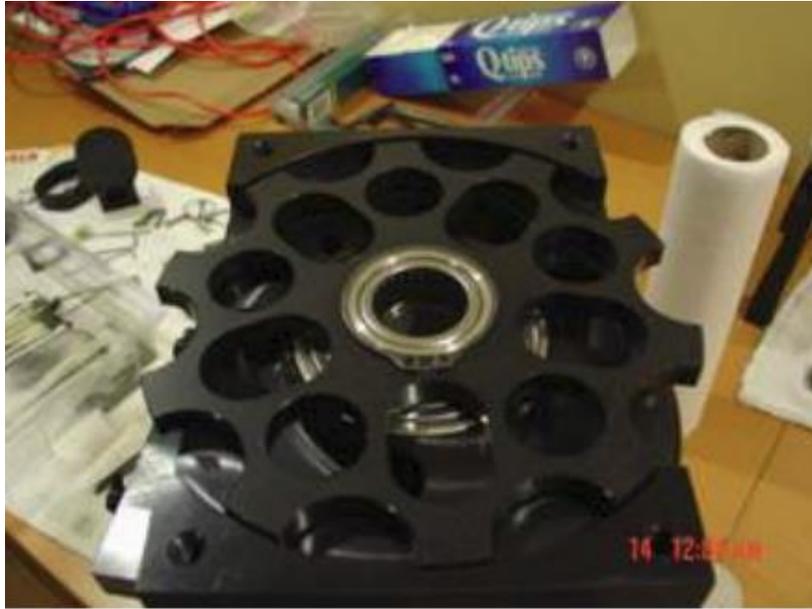
Photo 10. The pressure wheel is mounted. Screw it down far enough to permit the snap ring to be installed. Photo from Titan Tips.

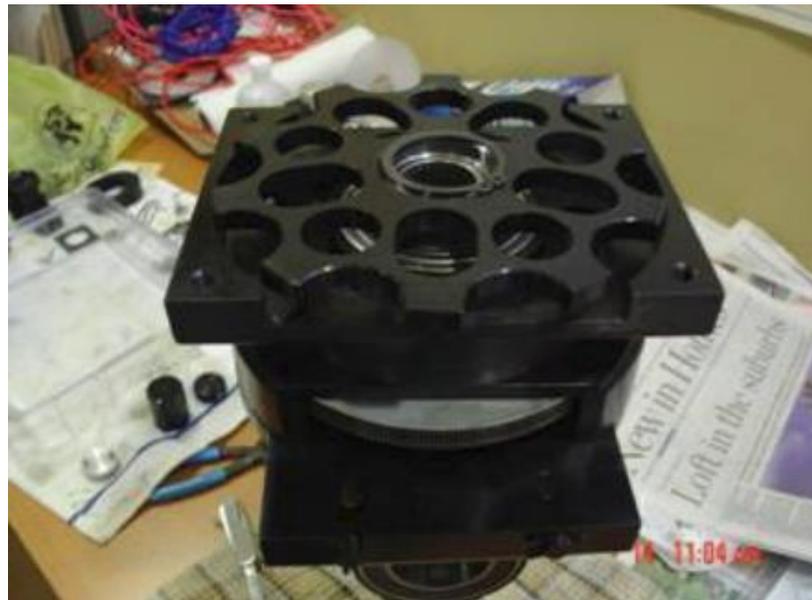
Photo 11. Snap ring shown before the pressure wheel is screwed down to permit installation. Photo from Titan Tips.

Once done, simply install the saddle with its shaft.
